## Ghost Buildings: The Structural and Performance Impact of Gaps in Terraced Rows Specialized Masonry Restoration

A Critical Analysis for Structural Engineers

Specialized Masonry Restoration  
October 2025

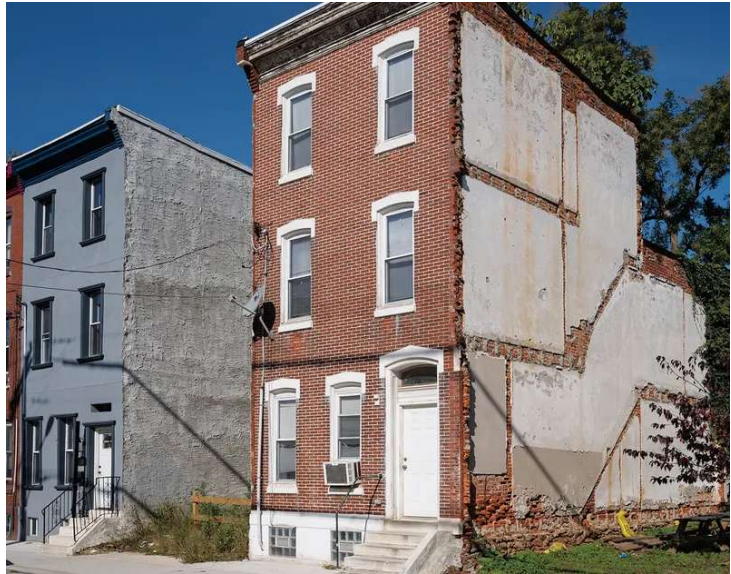
- Terraced houses are interdependent lateral bracing systems.
- Party walls were designed as internal, load-bearing elements, not external bracing.
- Removal of an intervening structure eliminates mutual buttressing.
- Exposed party walls become unbraced cantilevers, vulnerable to external forces.

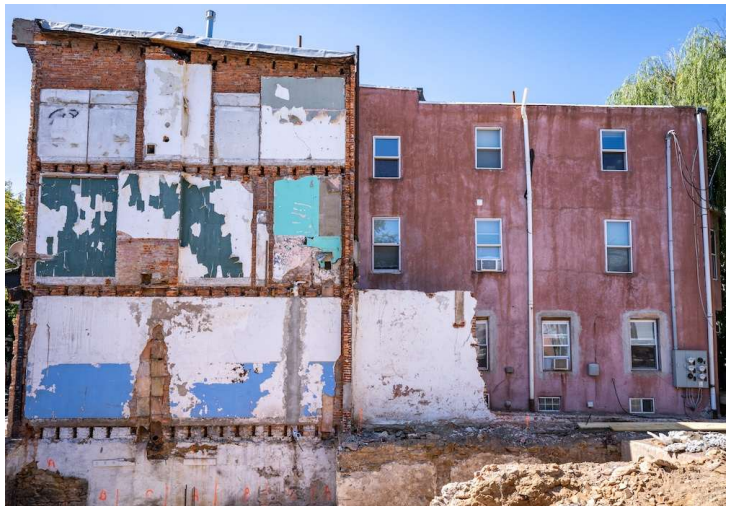
- **Removed Floor/Roof Joists:** Joists from the demolished house no longer provide critical tying into the party wall.
- **Roof Spread:** Absence of roof-level restraint can lead to roof spread, particularly in traditional timber rafter roofs.
- **Shared Chimney Stacks:** Unbraced chimneys become highly unstable, especially if they were shared or partially supported by the demolished structure.
- **Progressive Collapse Risk:** Cascading failure of other elements due to loss of interconnectedness.

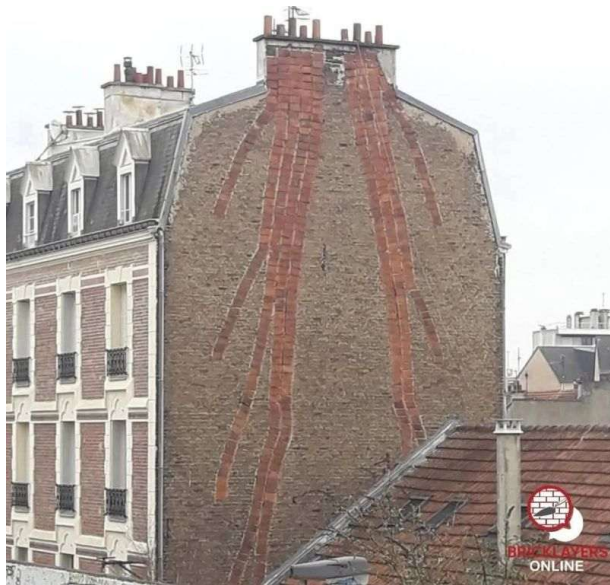
**And don't forget  
the chimneys!**

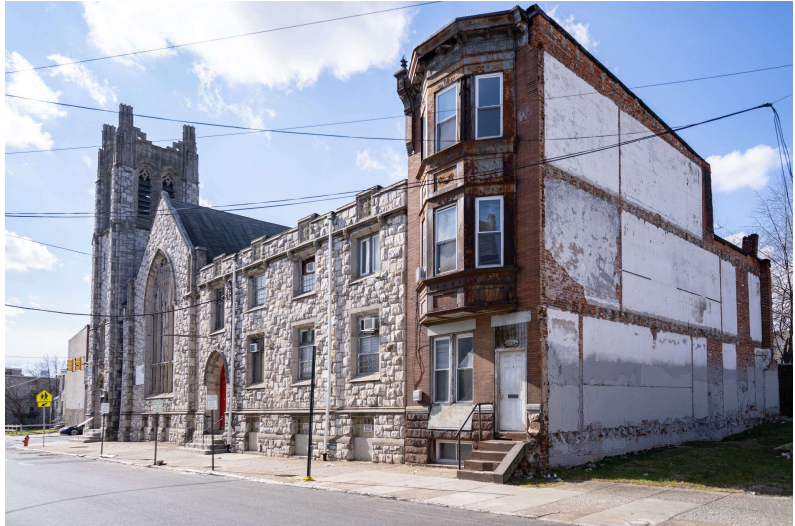
- **Porous Materials:** Internal party walls often constructed with softer, more absorbent bricks/blocks and lime mortar.
- **Rapid Water Absorption:** Exposed surfaces quickly become saturated with rain, leading to deep penetration.
- **Severe Damp & Mold:** Water ingress causes extensive internal damp, efflorescence, and black mold growth.
- **Frost Damage (Spalling):** Trapped moisture freezes in colder climates, causing brick faces to spall and mortar to degrade.

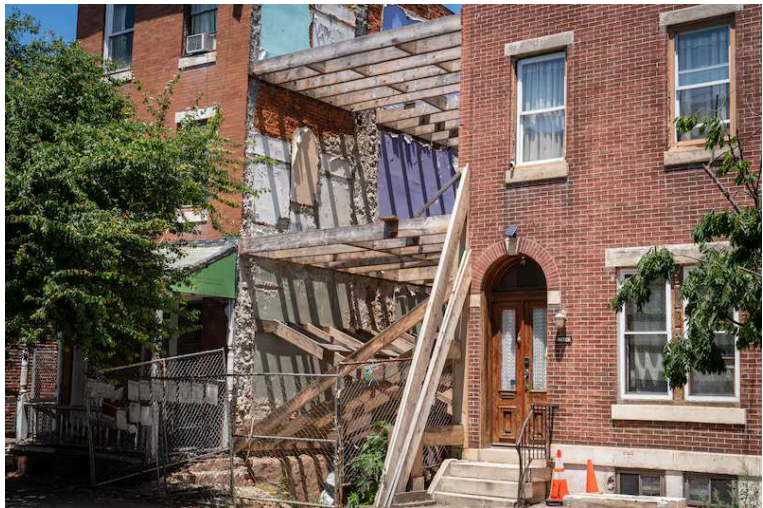
- **Qualified Structural Engineer First:** Mandate immediate engagement of a licensed P.E.
- **Safety Perimeter:** Establish clear exclusion zones around the structure due to collapse risk.
- **Temporary Propping & Shoring:** Install temporary props and shoring to stabilize the exposed party wall and potentially the roof/chimney.
- **Weather Protection:** Implement temporary weatherproofing (e.g., heavy-duty tarpaulins, sheeting) to prevent further water ingress.

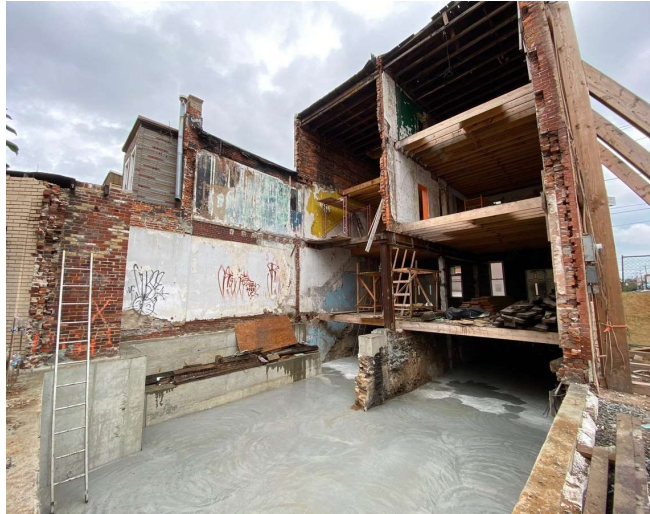
- **Permanent Buttressing:** Construction of new, adequately founded buttressing piers or a new independent wall at the site of the demolished structure.
- **Steel Wind Posts/Columns:** Installation of vertical steel members tied back to the floor/roof structures for lateral support.
- **Cross Wall Ties/Anchors:** Reinforcement of existing connections between the exposed party wall and internal cross walls.
- **Roof & Chimney Support:** Comprehensive repair and reinforcement of roof structure and any unstable chimney stacks.

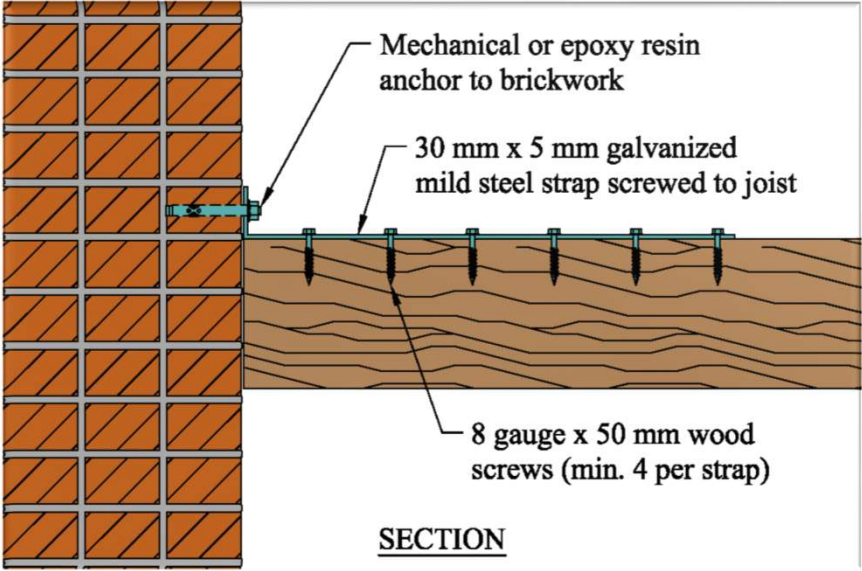
**Muuranker style of retrofit wall repair utilizing straps along the top of the joist**

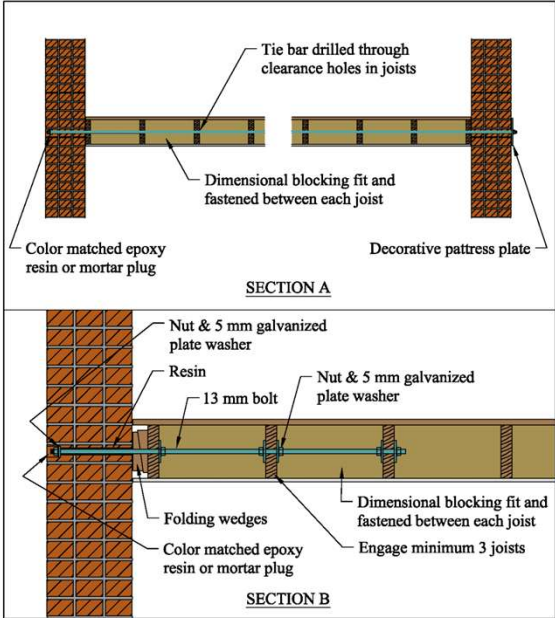
Alternatives for lateral wall ties utilizing existing transverse floor elements.

**SECTION A**

**SECTION B**

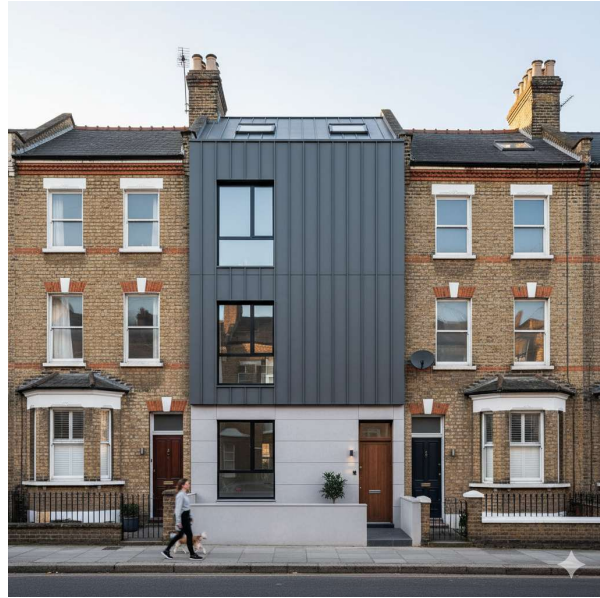
- **Exterior Rendering/Cladding:** Application of durable, waterproof exterior finishes (e.g., render, rainscreen cladding) over the exposed wall.
- **External Wall Insulation (EWI):** Crucial for restoring thermal performance and preventing condensation.
- **Professional Flashing & Sealing:** New, robust flashing at roof junctions and meticulous sealing of all interfaces.
- **Internal Finishes & Damp Treatment:** Repair of internal surfaces, including damp-proofing and mold remediation
